# PRELIMINARY REPORT

**Investigation COL-16-37-GIA**  
**Fuel Exhaustion**  
**Accident on 29, November 2015**  
**Aircraft AVRO 146-RJ85, Reg. CP2933**  
**La Unión, Antioquia – Colombia**

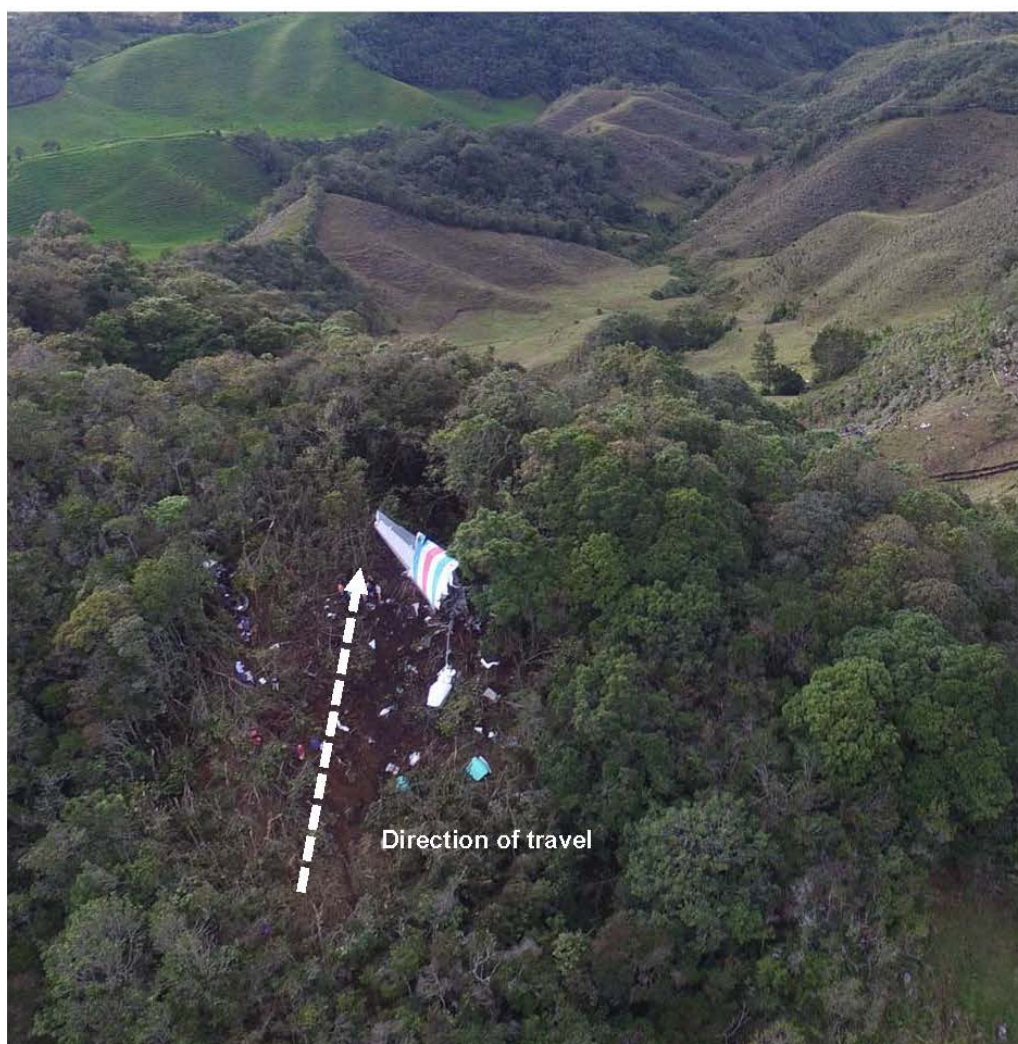
The initial point of impact was identified on the south face at the hill just below the hill ridge on an approximately  $310^{\circ}$  compass heading. According to the GPS readings, an energy path extended from the IPI approximately 140 meters down the north hill face to the main wreckage location, on an approximate  $290^{\circ}$  compass heading.

*Figura 4. Direction of travel*

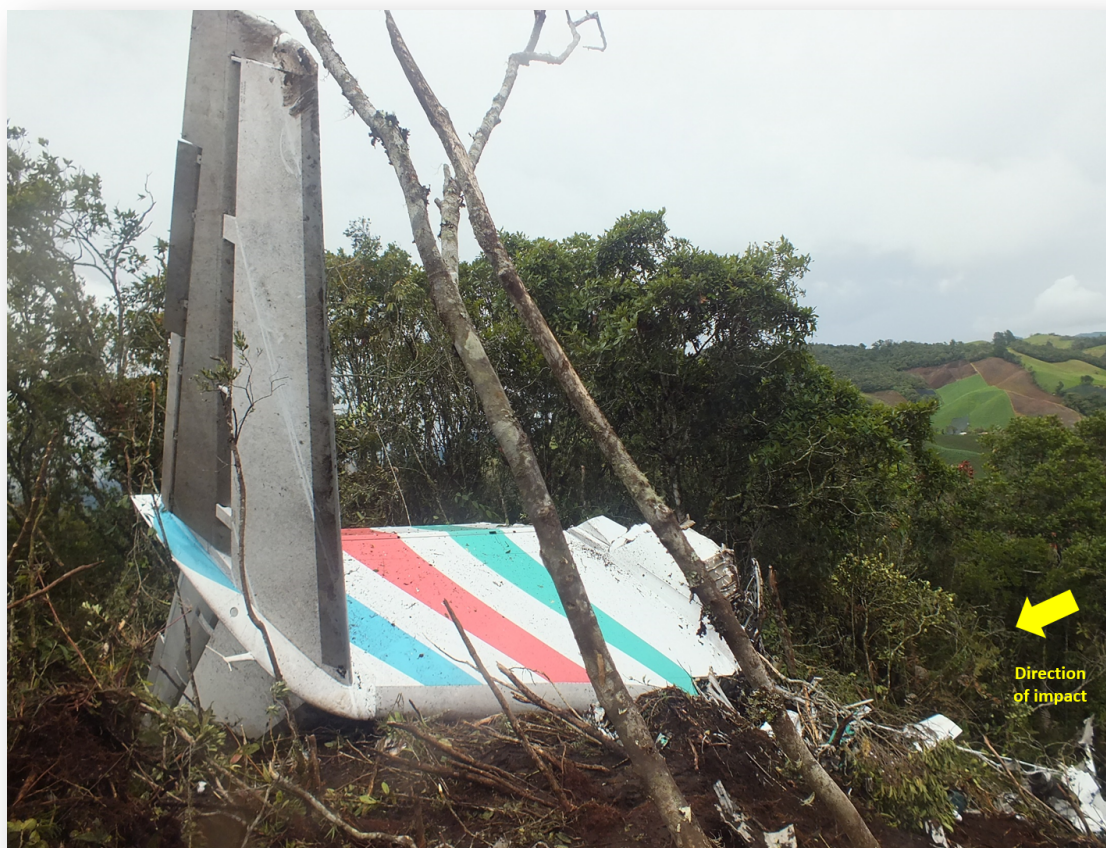
The approximate GPS position of the initial impact site was  $N05^{\circ}58'43.56'' - W075^{\circ}25'7.86''$ . The largest item was the tail unit, complete with rudder and both elevators (Figure 4 and 5). The tail unit had detached from the main fuselage at the pressure bulkhead frame. The leading edges of the horizontal stabilizers and fin were in good condition with little evidence of damage. The airbrakes were close to the tail unit and remained attached to it by electrical wiring.

*Figure 5 Tail unit showing fin leading edge*

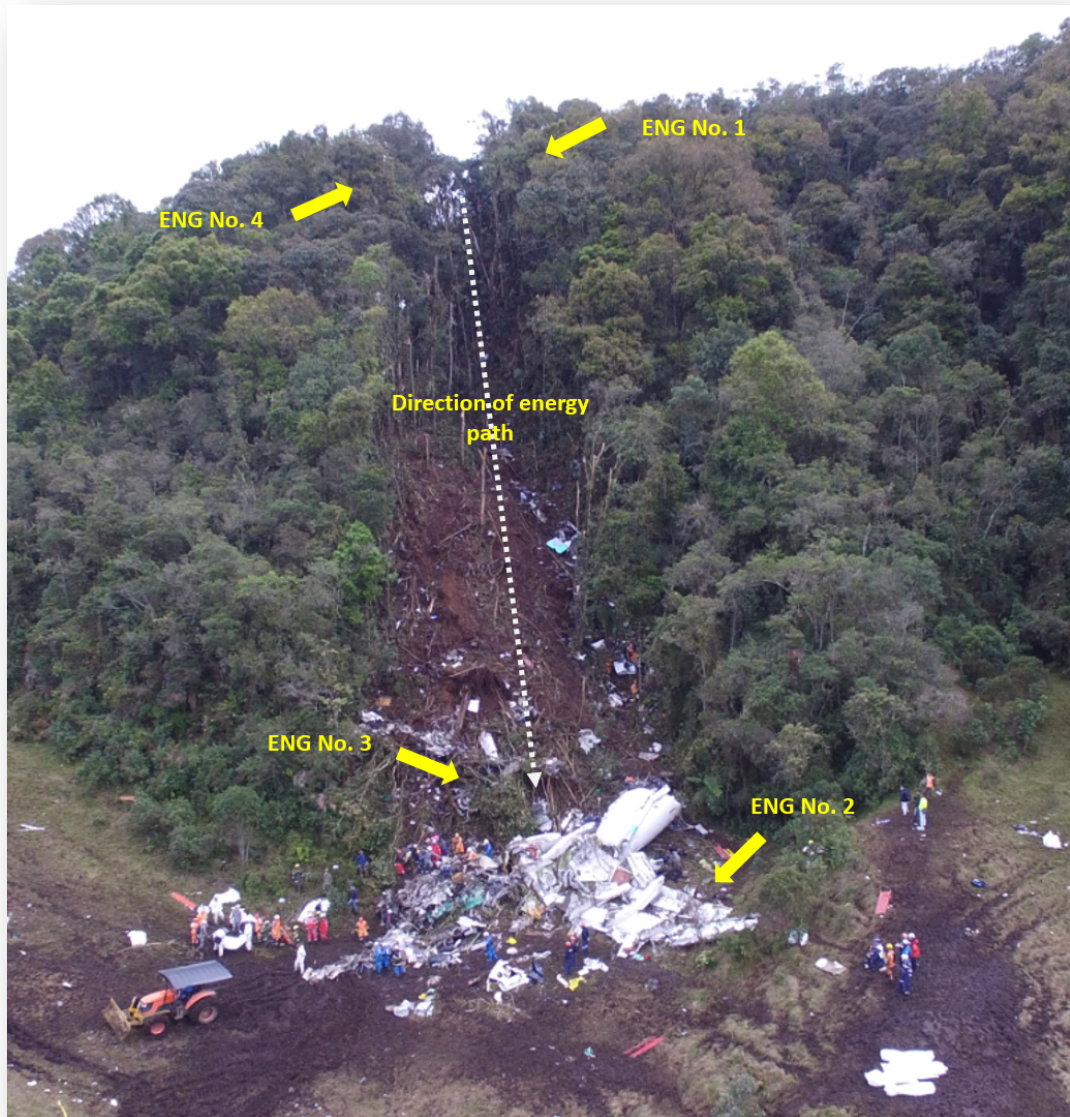
The Number 1 and Number 4 engines were found in the proximity to the initial impact point, with Number 1 engine to the left of the impact site and Number 4 to the right. Number 2 and Number 3 engines were found in the area of the main wreckage with Number 2 engine to the left of the area and Number 3 to the right (Figure 6). The Number

3 engine was found lying in a large uprooted tree on a slope which was considered unstable and a thorough examination of the engine was not possible.

*Figure 6. Engines locations in main wreckage site*

Examination of the Number 1, 2 and 4 engines revealed no evidence of fire, uncontainment, or internal engine failure. There was varying amounts of damage to the engines and each had soil and tree debris packed between the fan blades. None of these engines showed any circumferential or spiral scoring to the fan spinner. The state of the engines examined was consistent with these engines not being under power at the time of impact.

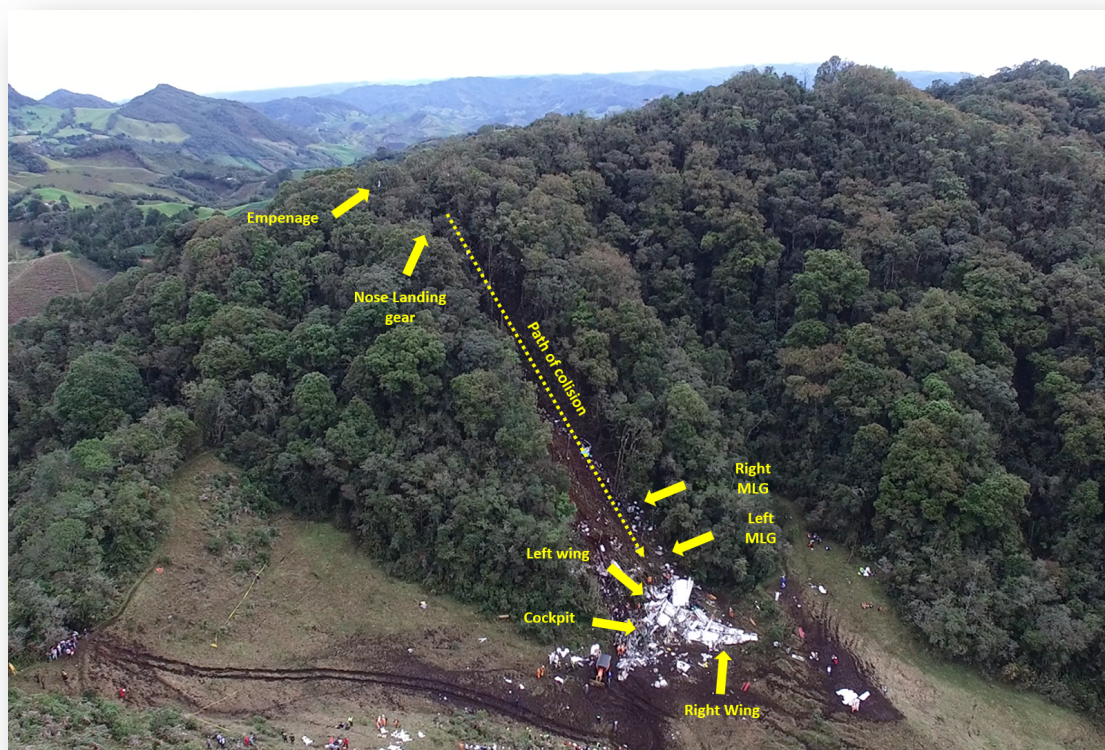
Major assemblies identified included the cockpit, forward fuselage, wings, rear fuselage and the Number 2 engine. The wreckage had travelled downhill, passing through and disrupting trees (Figure 7).

*Figure 7. Location and path of the main wreckage through the trees*

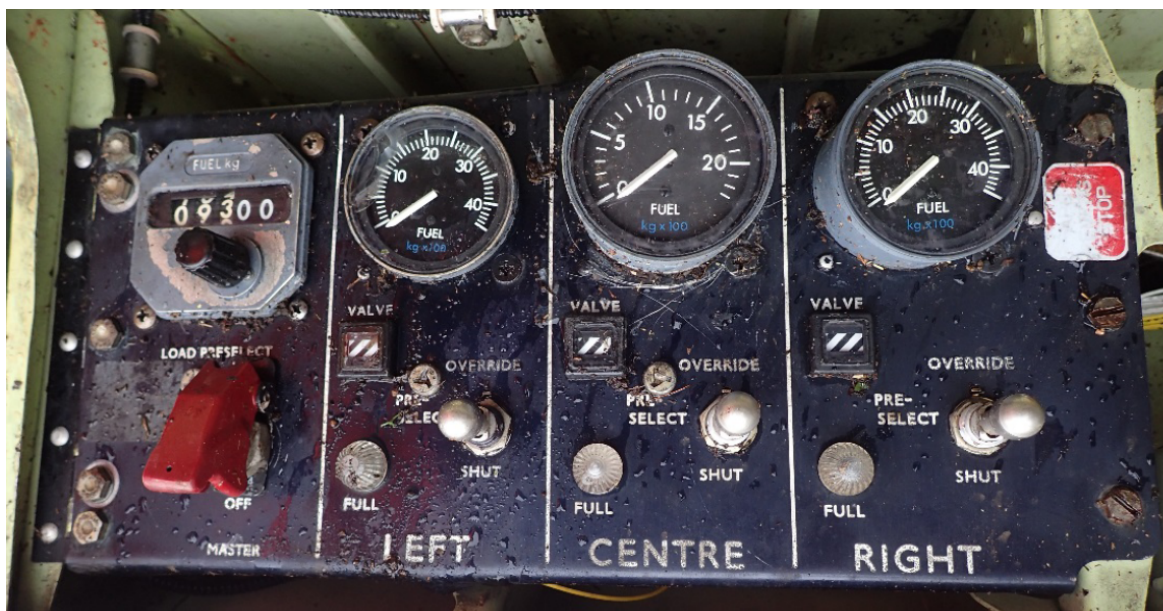
The refuel panel (Figure 8) had a fuel upload of 9,300 kg selected. All the three fuel contents gauges within the panel indicated below zero, commensurate with readings when electrical power is removed. The three fuel valve selection switches were in the PRE-SELECT position.

Figure 8 Refuel panel
