**APENDICE "A"****ACCIDENTE HK-4682, SAN ANDRES-COLOMBIA**
**RESUMEN ESTADO FUNCIONAL INFRAESTRUCTURA AERONAUTICA EN  
LA ISLA DE SAN ANDRES- COLOMBIA**

**GROUP CHAIRMAN'S FACTUAL REPORT OF  
INVESTIGATION**

**DCA10RA085**

On August 16, 2010, about 0149 local time (0249 eastern daylight time), an Aires B737-700, HK-4682, crashed short of the runway at San Andres Island Airport (ADZ), San Andres Island, Colombia. There were 121 passengers and 6 crew on board. The airplane was severely damaged and there were 2 fatalities, 15 serious injuries and 66 minor injuries.

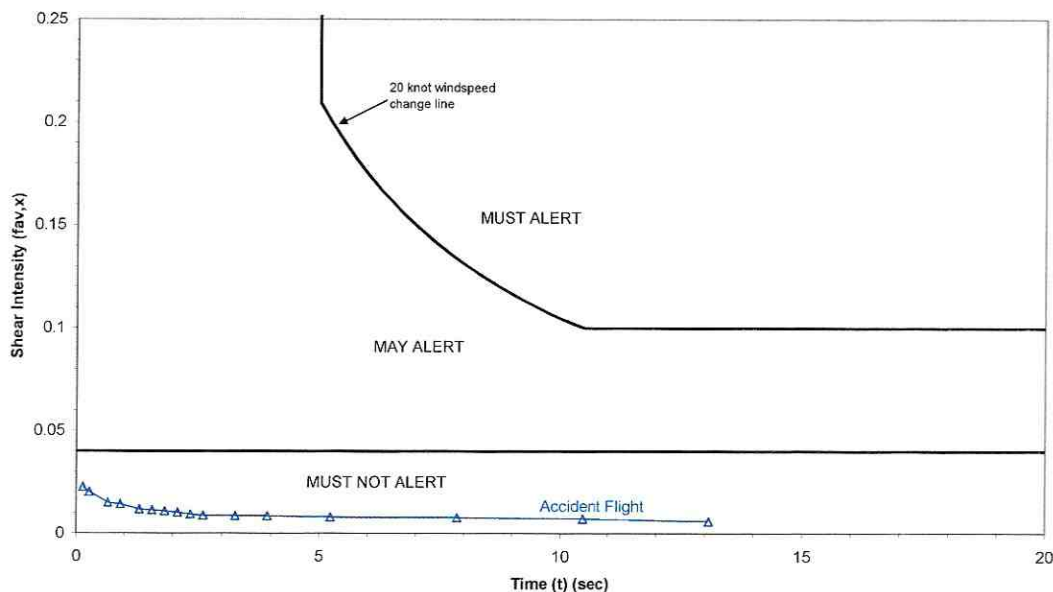
**Reactive Windshear  
Shear Intensity Curve**  
(Ref: TSO-C117 Page 8 Figure 1)

Calculated values of  $f_{av,x}$  are shown for the accident flight in blue on the above plot. The results show that some decreasing performance windshear was present, but it was well below the alert threshold. Specifically, the values of average shear intensity are below the “must not alert” threshold defined in the TSO.

The above analysis is based on the requirements contained in TSO-C117a. It is important to note that the actual calculations performed by the EGPWS computer are different, but have been demonstrated to produce results which meet the TSO requirements. Analysis of the accident flight data based on the calculation method actually used by the EGPWS confirmed that no reactive windshear alert was expected.

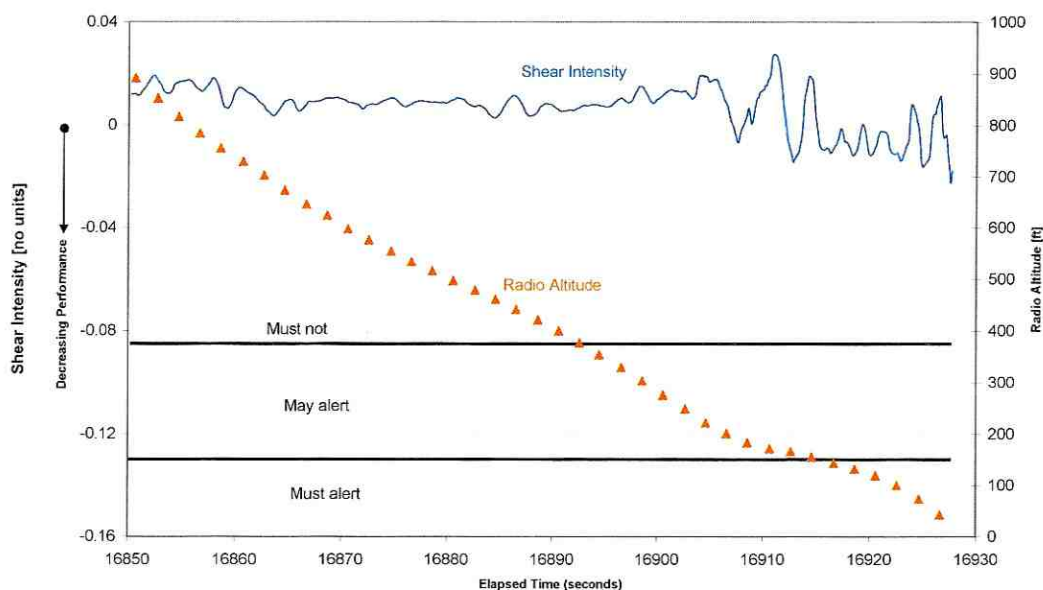
**Aires 737-700 HK-4682**  
**Predictive Windshear Analysis**

The WXR does not record actual radar returns, thus the raw data to confirm whether a predictive windshear condition existed is not available. However, based on the observed values of shear intensity which remained below 25% of the "must not alert" threshold, no predictive windshear alert (either caution or warning) was expected.

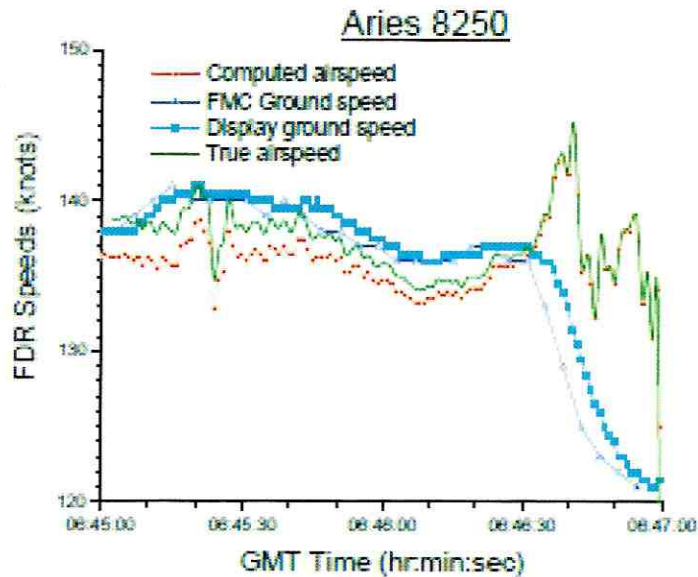
Figure 9 True airspeed

The calculated true airspeed is plotted with FDR computed airspeed and ground speed in figure 9. A comparison of true airspeed with ground speed in figure 9 reveals slight winds (generally

one to three knots) for most of the approach followed by a moderate headwind for the last 30 seconds of the flight (winds will be discussed in detail in a following section).

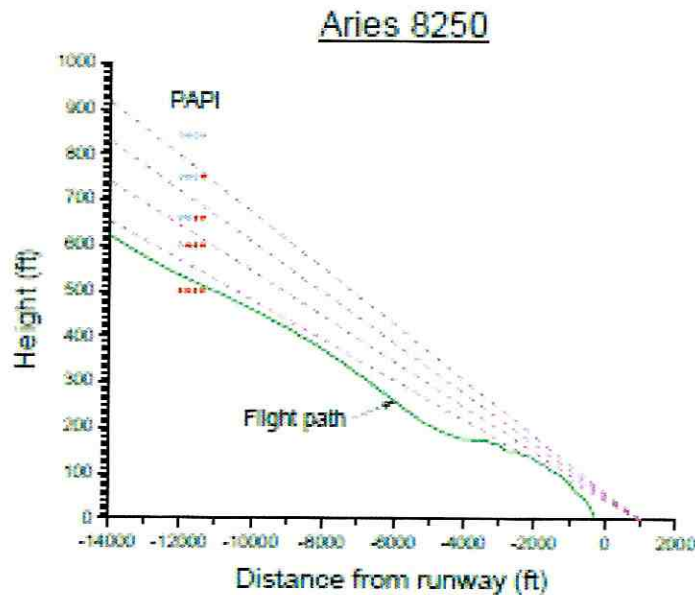
Figure 17 flight path profile comparison to PAPI.

Runway 6 at Gustavo Rojas Pinilla was equipped with a PAPI visual approach system. It was desired to determine the position of the flight path relative to the PAPI light signal zones. To accomplish this, the position time history from the velocity integration was rotated to the runway axis and eye height elevation plotted against distance from the end of the runway. Eye height elevation was obtained by adjusting the AGL altitude determined above for pitch angle using the distance between the center of gravity and the pilot's station. The resulting plot is shown in figure 17. As can be seen, the flight path was below the glide slope in the 4 red light PAPI altitude zone until the aircraft was about 1/3 Nautical miles out when the aircraft briefly entered the 3 red and one white PAPI signal altitude zone.

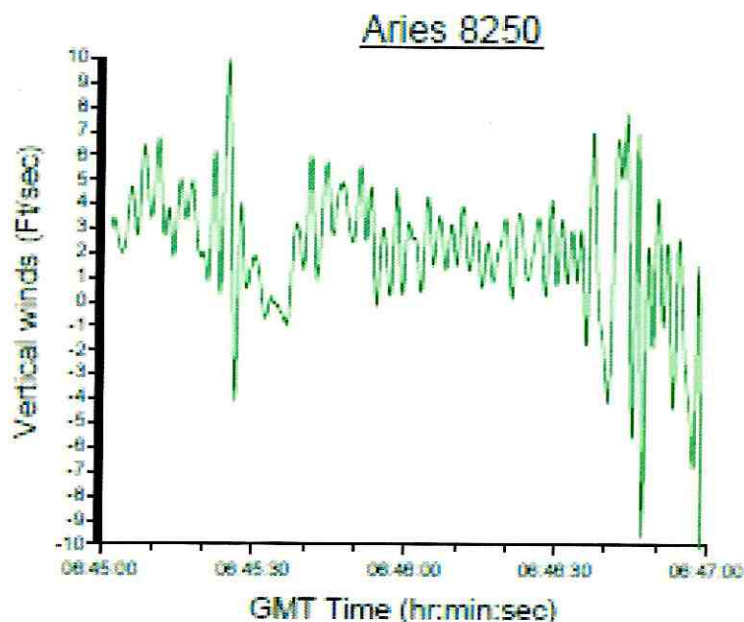
**Figure 20 Vertical wind**

Vertical wind was calculated using sensed angle of attack and recorded aircraft state and Euler angles and is shown in figure 20. Vertical wind is very light throughout the approach.

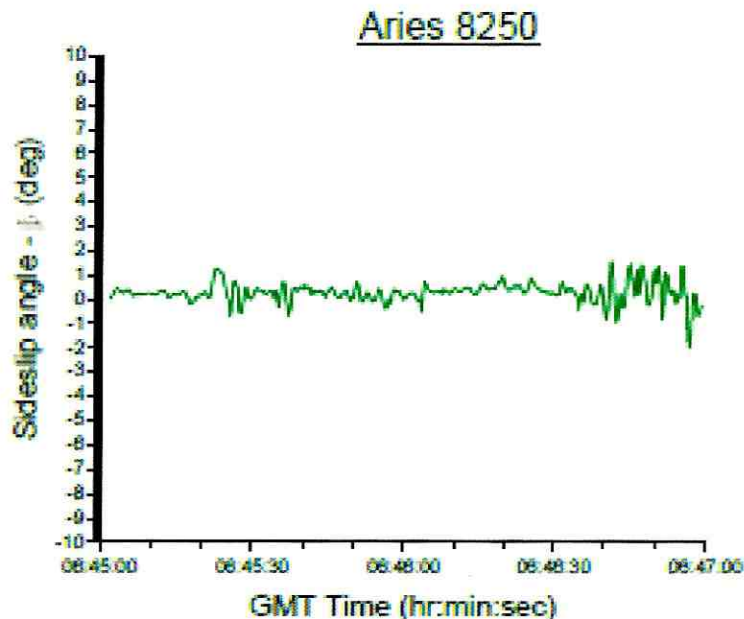
**Figure 21 Sideslip angle**

A kinematics extraction was performed to investigate whether a rotation wind (that is a vortex) or a wind shear could have contributed to the accident. While horizontal wind direction and velocity can be derived directly, rotational winds can be seen indirectly as a change in pitch, yaw and roll aerodynamic moment coefficients ( $C_m$ ,  $C_n$  and  $C_{roll}$ ) required for the aircraft's motion. For the purpose of this study, the accident aircraft was approximated with a 737-300 flight model with 737-700 geometry. Thus some care is required in interpreting the results. This extraction used the FDR offsets identified through the flight path integration match previously discussed. Sideslip is shown in figure 21. As can be seen, sideslip remains small and there is no evidence of any significant external disturbance.

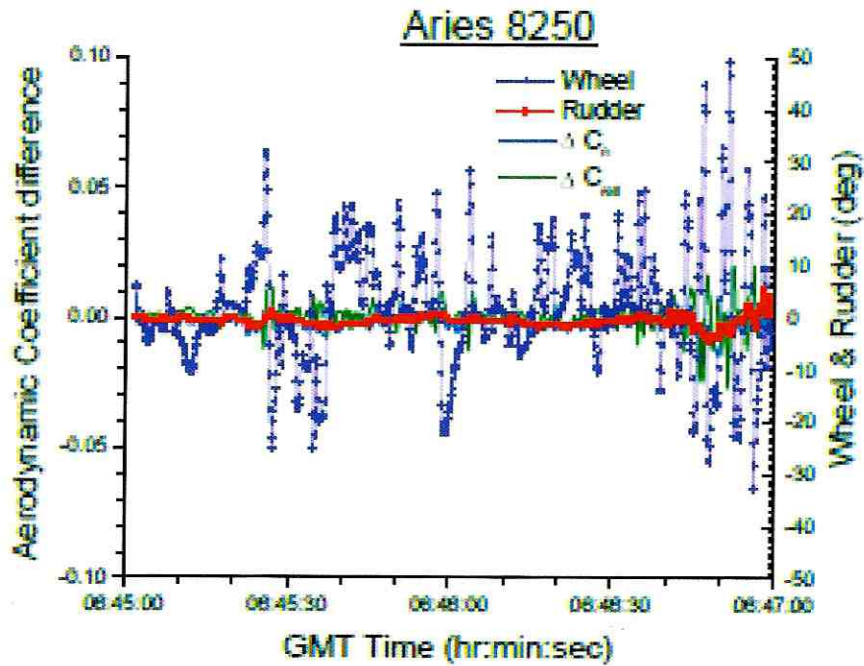
Figure 22 Yaw & roll coefficient differences

The effect of rotational winds (or lack thereof) can be seen in the extracted difference in yawing, rolling and pitching moment coefficients. These differences are shown in figures 22 and 23 and represent the difference between the aerodynamic coefficients required for the aircraft's motion and the aerodynamic coefficients from the simulation for the recorded aircraft state and control inputs. Since the difference also includes modeling differences due to the use of the 737-300 model with 737-700 geometry in lieu of a complete 737-700 model, the coefficients differences are plotted with variables that would impact these modeling differences. As can be seen in figure 22 the differences in yawing and rolling coefficients between the model and the accident flight are small and correlate with control movement (where modeling differences are likely). This indicates that any rotational winds in the yaw and roll axis are small. Further, the small fraction of roll and yaw control used indicates that any rotational winds in the yaw and roll axis were easily within controllable limits.

changes in these controlling parameters. Accordingly any rotational wind in pitch is at a low level below the detection threshold for this method. Again, the small changes in pitch control input indicate that there were no controllability issues in the pitch axis.

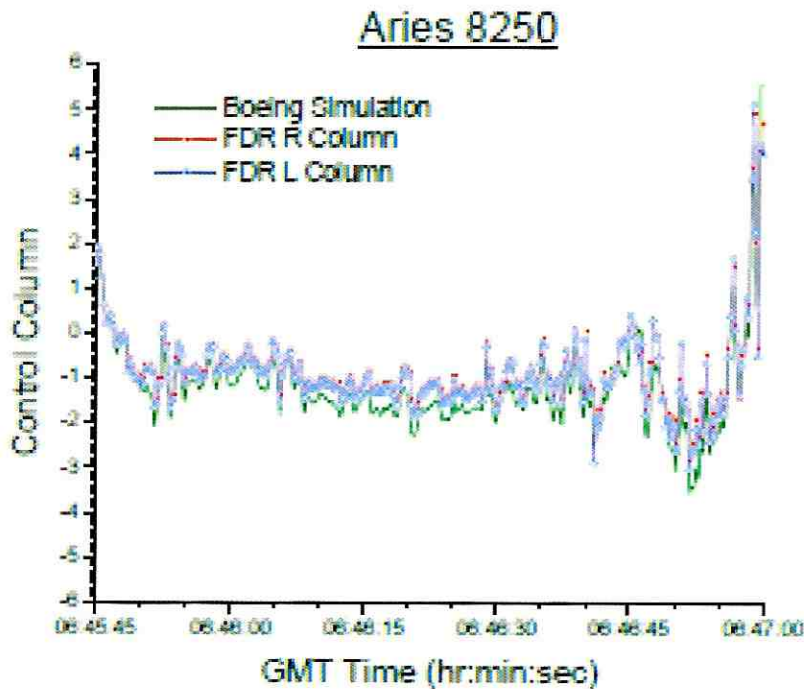
Figure 30: Control column comparison

by the FDR would represent unaccounted for forces and moments acting on the aircraft. As can be seen in figures 30 and 31, the control column and power level required to match the airplanes recorded motion (which was essentially in the longitudinal plane for the approach) with the simulation matches the recorded longitudinal controls. Accordingly, the Boeing simulation verifies that the airplane performed as expected in the calculated wind field.
