Grupo de Investigación de
Accidentes e Incidentes aéreos

PRELIMINARY REPORT

Investigation COL-16-37-GIA
Fuel Exhaustion
Accident on 29, November 2015
Aircraft AVRO 146-RJ85, Reg. CP2933
La Unión, Antioquia – Colombia

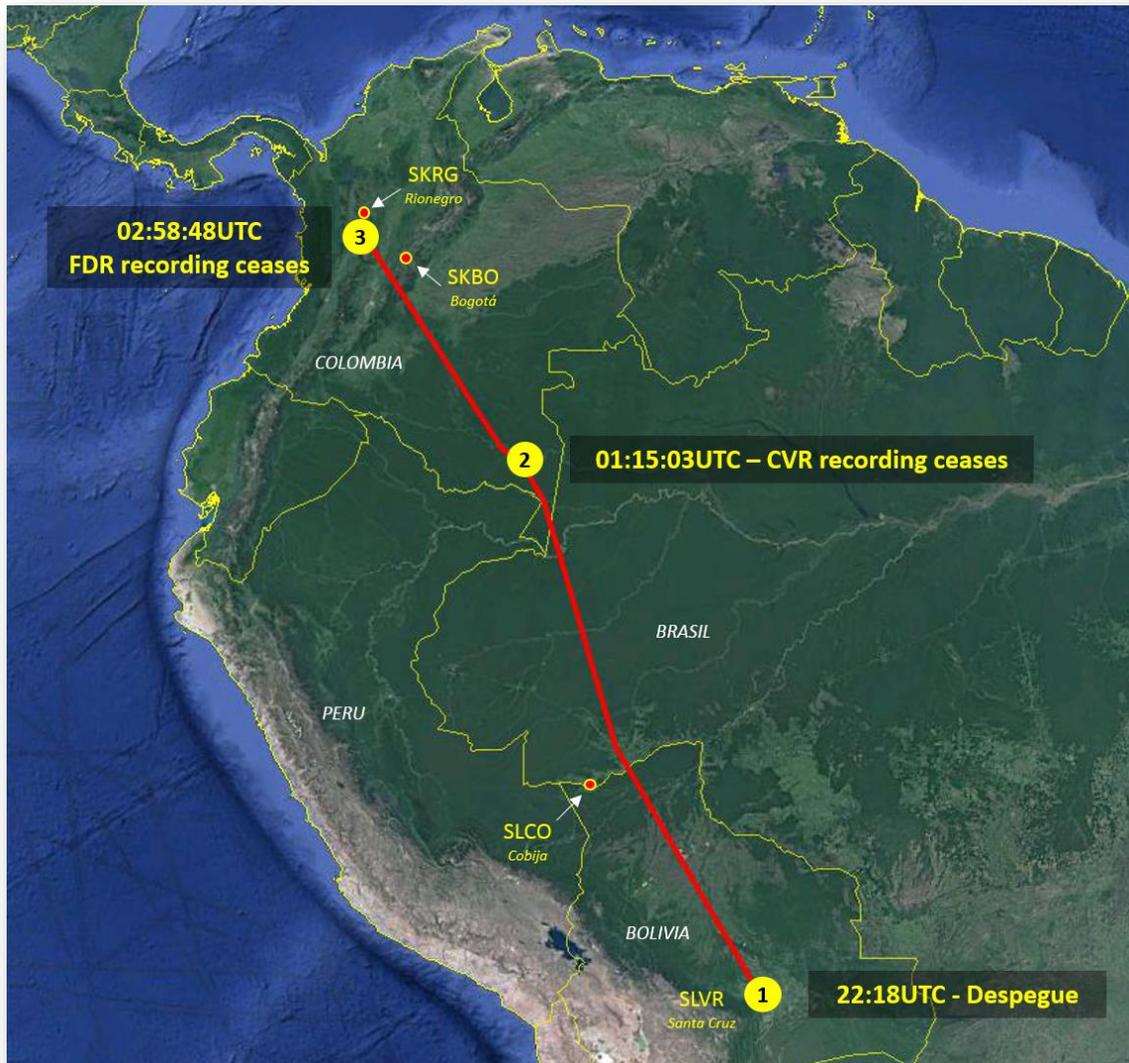
Figure 1. Aircraft flight track from FDR recording

The aircraft took off at 22:18hrs and climbed to an initial cruising flight level of FL260, levelling at 22:41hrs. It then climbed again at 22:49hrs to FL280, levelling at 22:58hrs. It then started climb to its final cruising level of FL300 at 23:54hrs, levelling at 00:14hrs. The cruising speed was recorded as 220 kt CAS. The route flown is shown in Figure 1.

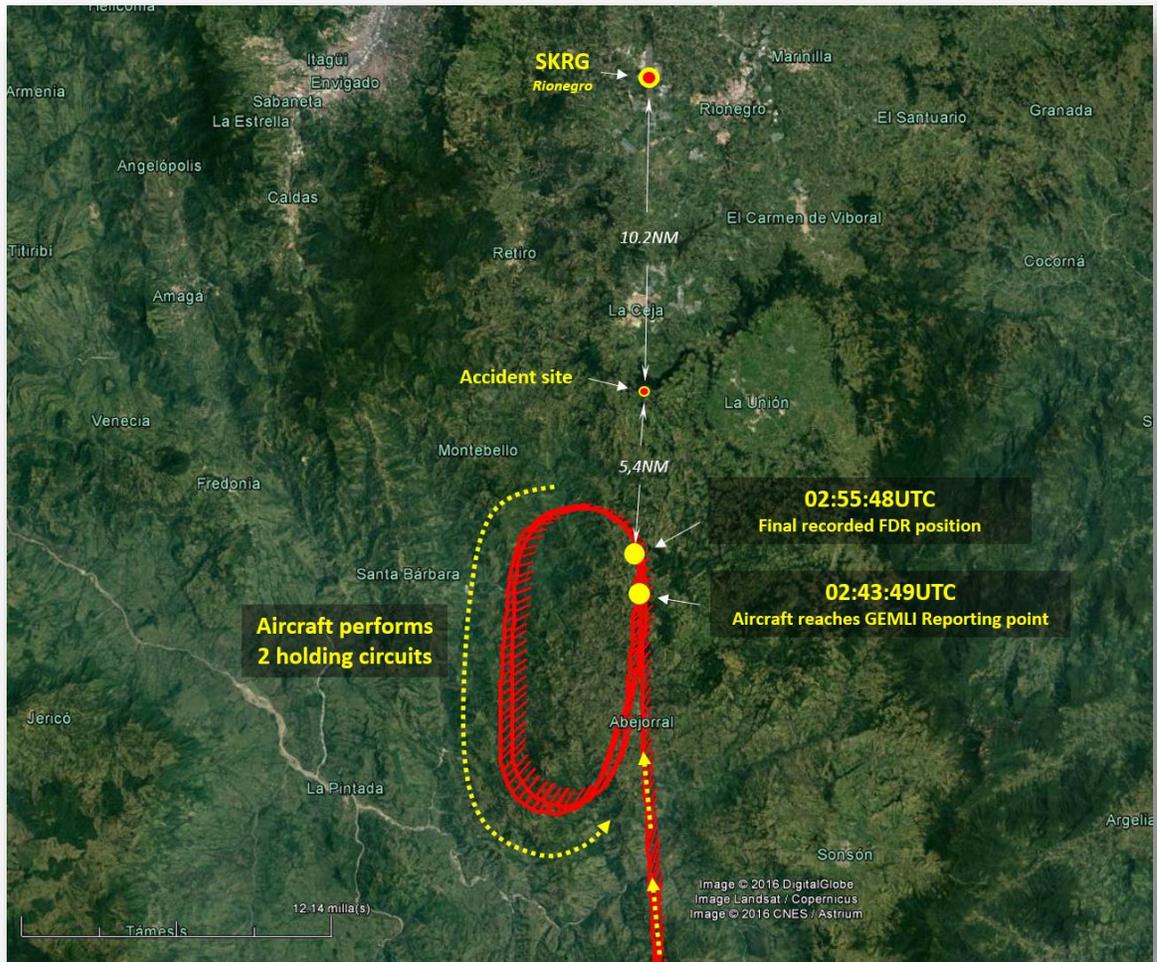
Figure 3. Aircraft track in the hold at GEMLI from FDR data

At 02:42:12hrs the crew was instructed to continue descent to FL210. At 02:43:09hrs the crew asked to hold at GEMLI RNAV Point (Figure 2), which was approved. It overflew GEMLI at 02:43:39hrs and entered the hold. (Figure 3 – each complete hold has a ground track of approximately 24 nm).

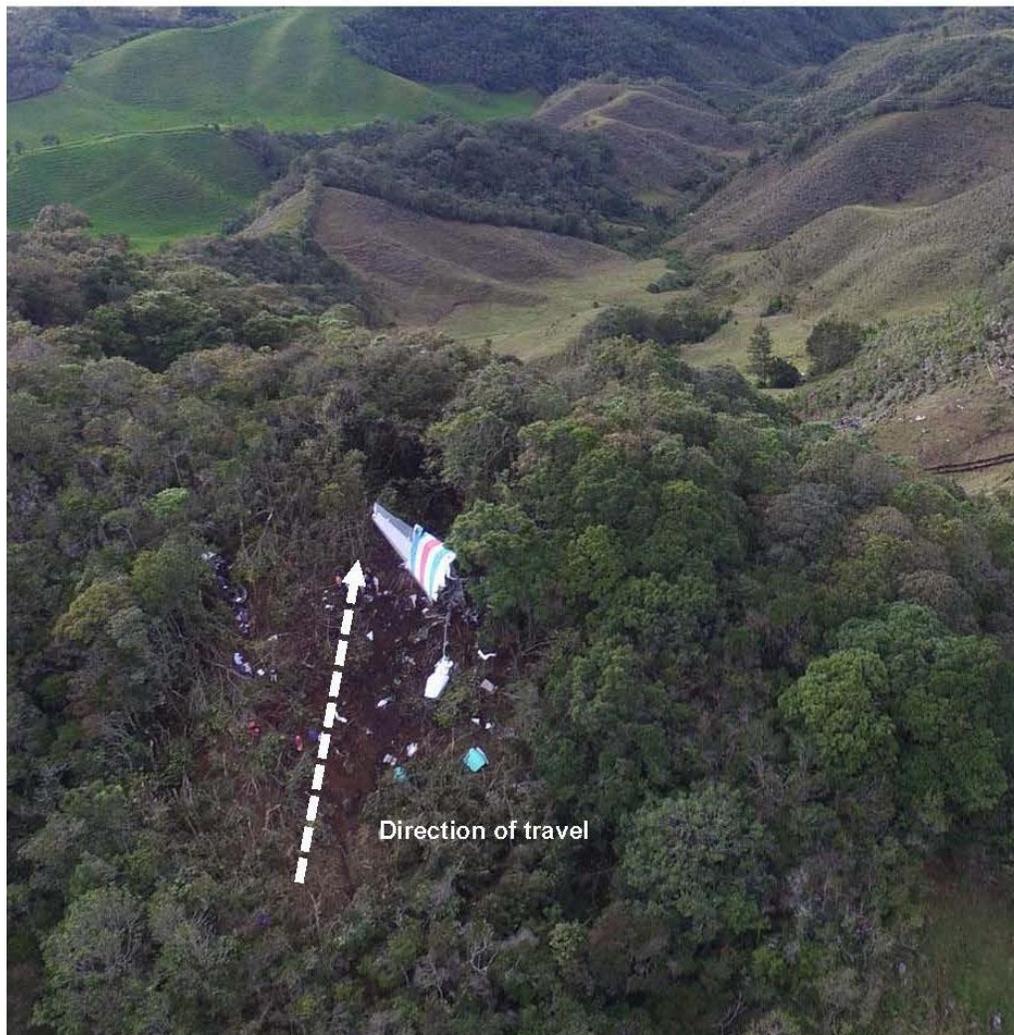
Figura 4. Direction of travel

The initial point of impact was identified on the south face at the hill just below the hill ridge on an approximately 310° compass heading. According to the GPS readings, an energy path extended from the IPI approximately 140 meters down the north hill face to the main wreckage location, on an approximate 290° compass heading.

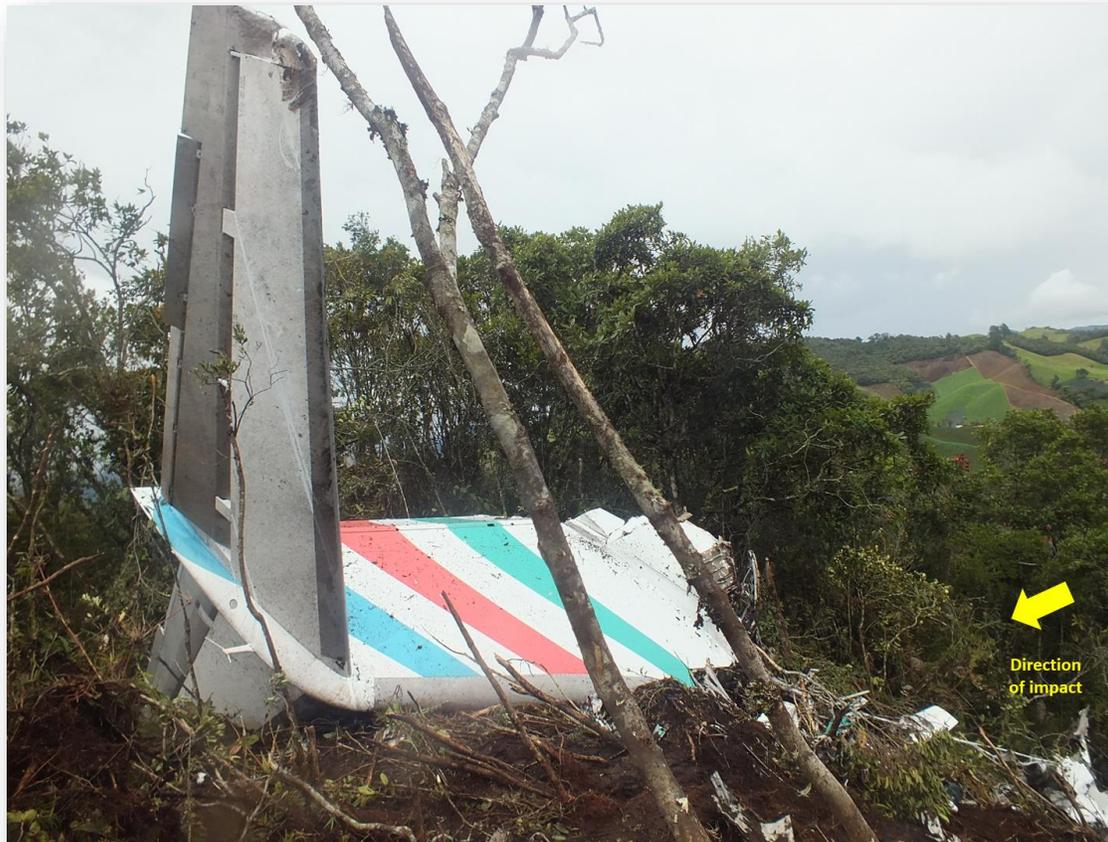
Figure 5 Tail unit showing fin leading edge

The approximate GPS position of the initial impact site was N05°58'43.56" – W075°25'7.86". The largest item was the tail unit, complete with rudder and both elevators (Figure 4 and 5). The tail unit had detached from the main fuselage at the pressure bulkhead frame. The leading edges of the horizontal stabilizers and fin were in good condition with little evidence of damage. The airbrakes were close to the tail unit and remained attached to it by electrical wiring.

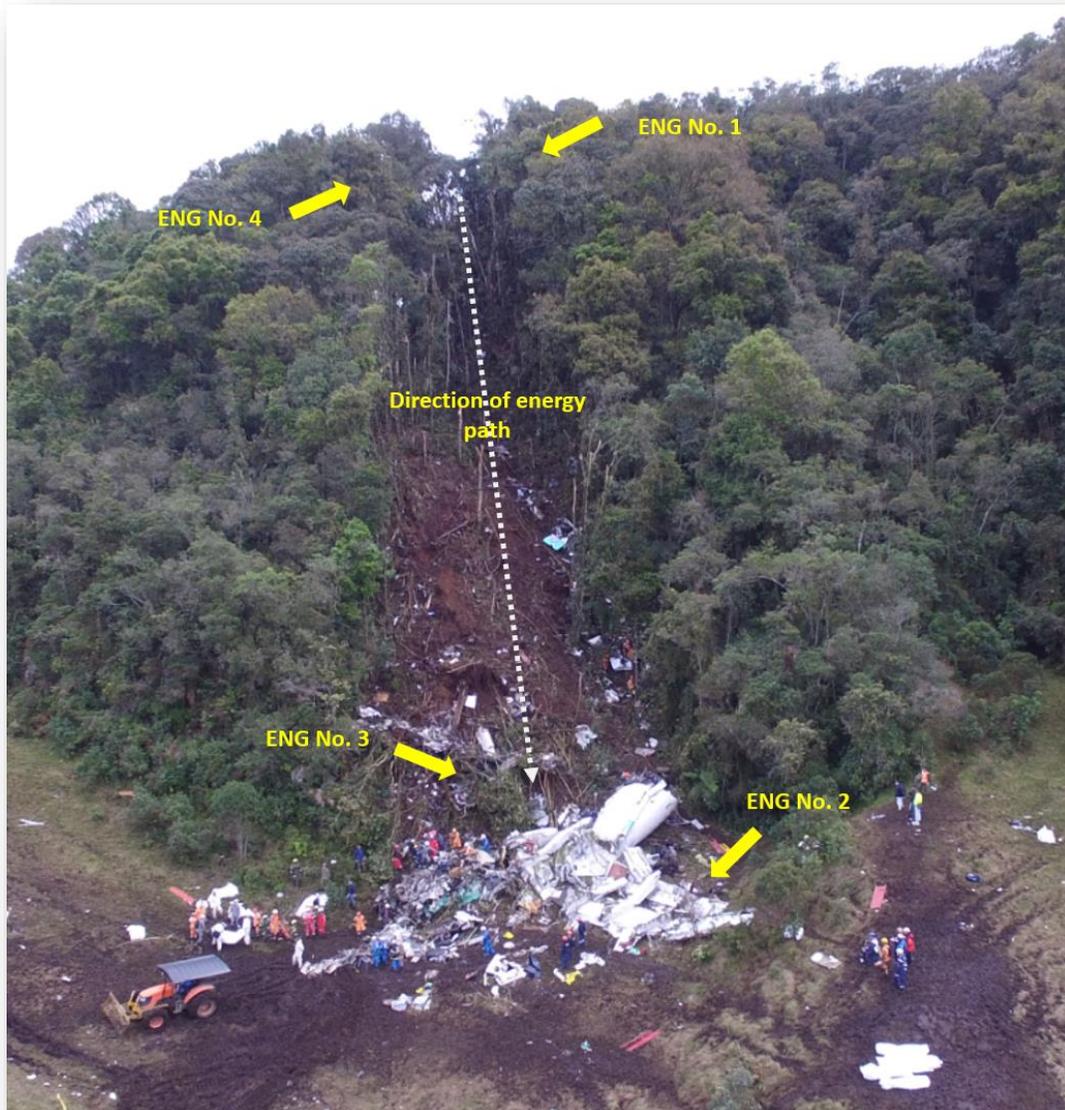
Figure 6. Engines locations in main wreckage site

The Number 1 and Number 4 engines were found in the proximity to the initial impact point, with Number 1 engine to the left of the impact site and Number 4 to the right. Number 2 and Number 3 engines were found in the area of the main wreckage with Number 2 engine to the left of the area and Number 3 to the right (Figure 6). The Number

3 engine was found lying in a large uprooted tree on a slope which was considered unstable and a thorough examination of the engine was not possible.

Examination of the Number 1, 2 and 4 engines revealed no evidence of fire, uncontainment, or internal engine failure. There was varying amounts of damage to the engines and each had soil and tree debris packed between the fan blades. None of these engines showed any circumferential or spiral scoring to the fan spinner. The state of the engines examined was consistent with these engines not being under power at the time of impact.

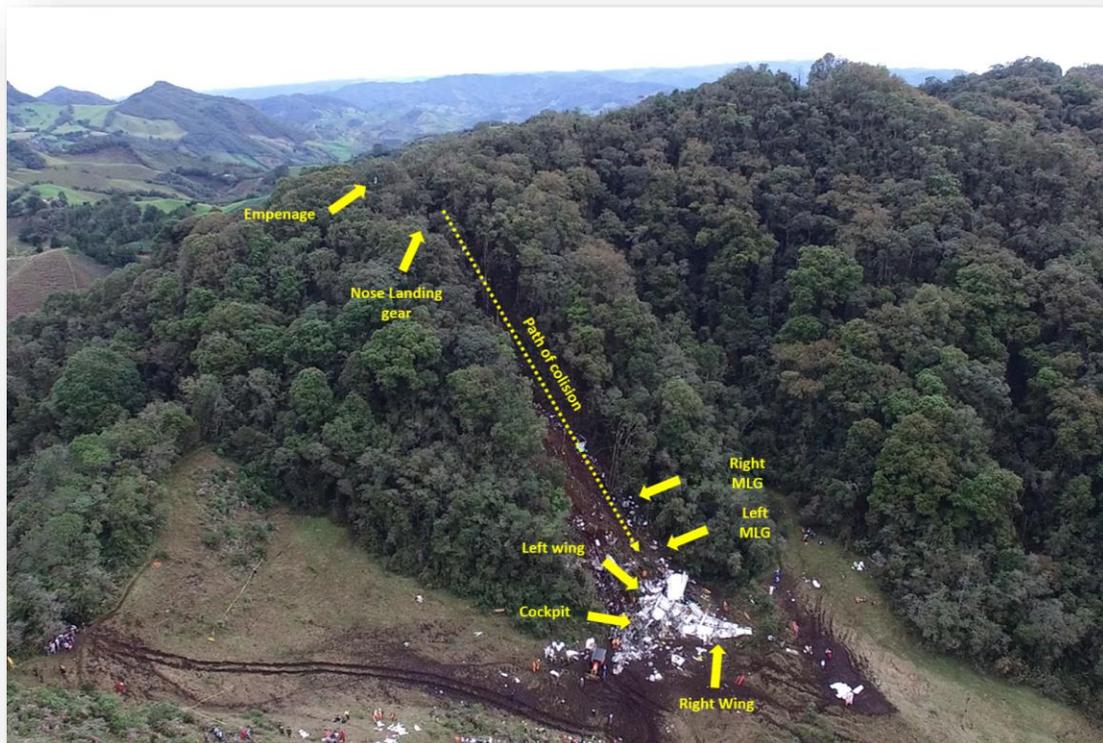
Figure 7. Location and path of the main wreckage through the trees

Major assemblies identified included the cockpit, forward fuselage, wings, rear fuselage and the Number 2 engine. The wreckage had travelled downhill, passing through and disrupting trees (Figure 7).

The wings remained attached to the centre box (which forms the centre fuel tank) and were in the direction of travel but inverted. The orientation of the wings indicates that the centre fuselage rolled through 180° after the tail unit separated. The rear fuselage was upright but was facing opposite to the direction of travel. The majority of the rear pressure bulkhead remained attached to the rear fuselage.

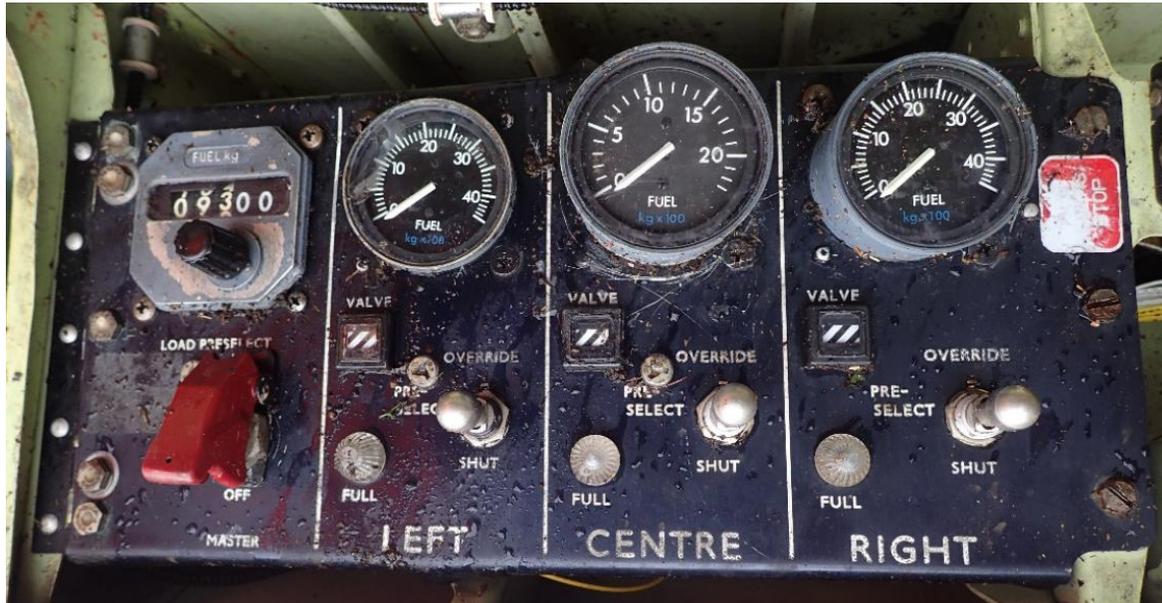
Figure 8 Refuel panel

The refuel panel (Figure 8) had a fuel upload of 9,300 kg selected. All the three fuel contents gauges within the panel indicated below zero, commensurate with readings when electrical power is removed. The three fuel valve selection switches were in the PRE-SELECT position.
