# PRELIMINARY REPORT

**Investigation COL-16-37-GIA**  
**Fuel Exhaustion**  
**Accident on 29, November 2015**  
**Aircraft AVRO 146-RJ85, Reg. CP2933**  
**La Unión, Antioquia – Colombia**

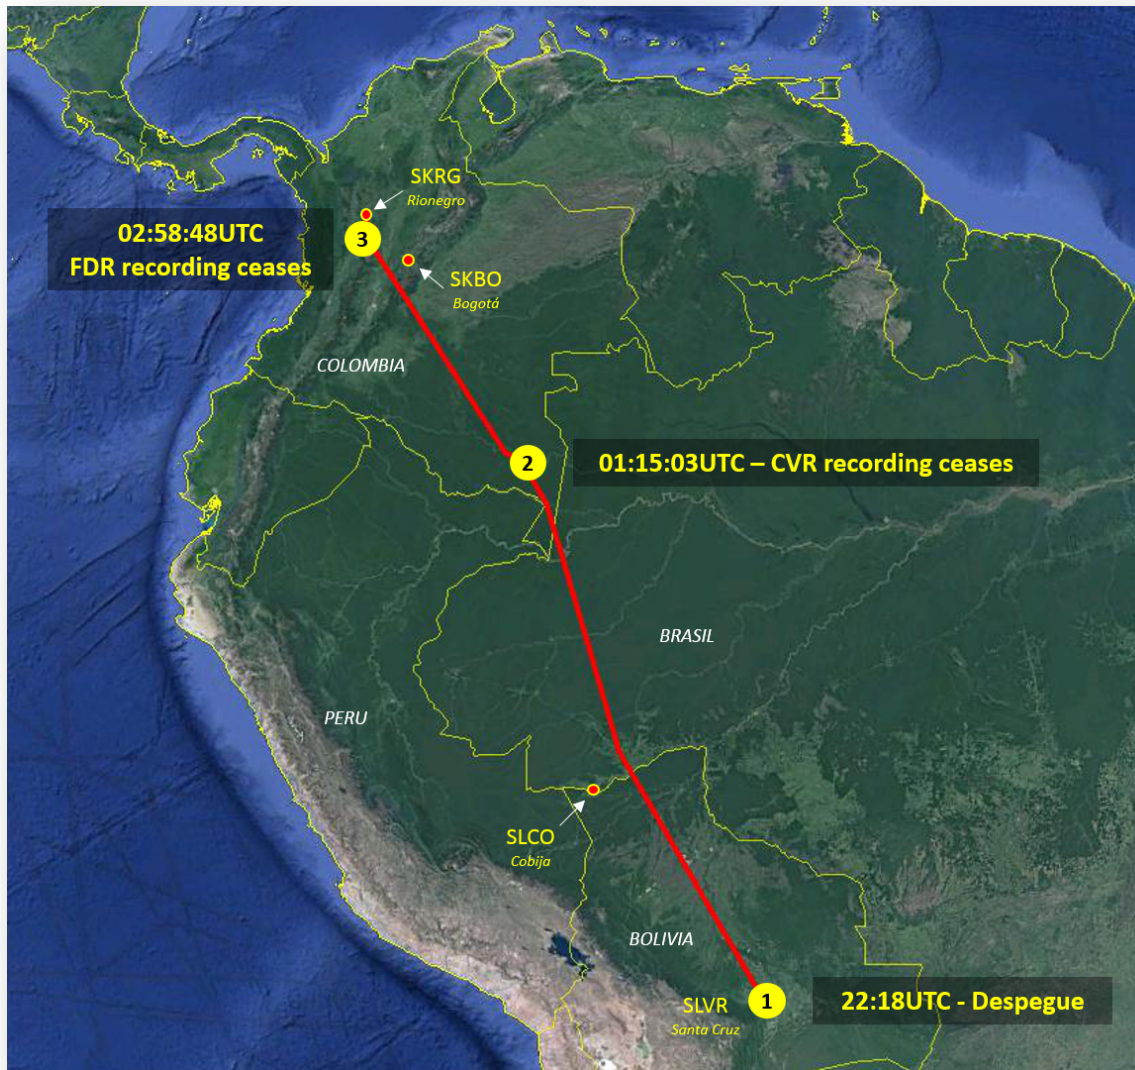
**Figure 1. Aircraft flight track from FDR recording**

The aircraft took off at 22:18hrs and climbed to an initial cruising flight level of FL260, levelling at 22:41hrs. It then climbed again at 22:49hrs to FL280, levelling at 22:58hrs. It then started climb to its final cruising level of FL300 at 23:54hrs, levelling at 00:14hrs. The cruising speed was recorded as 220 kt CAS. The route flown is shown in Figure 1.

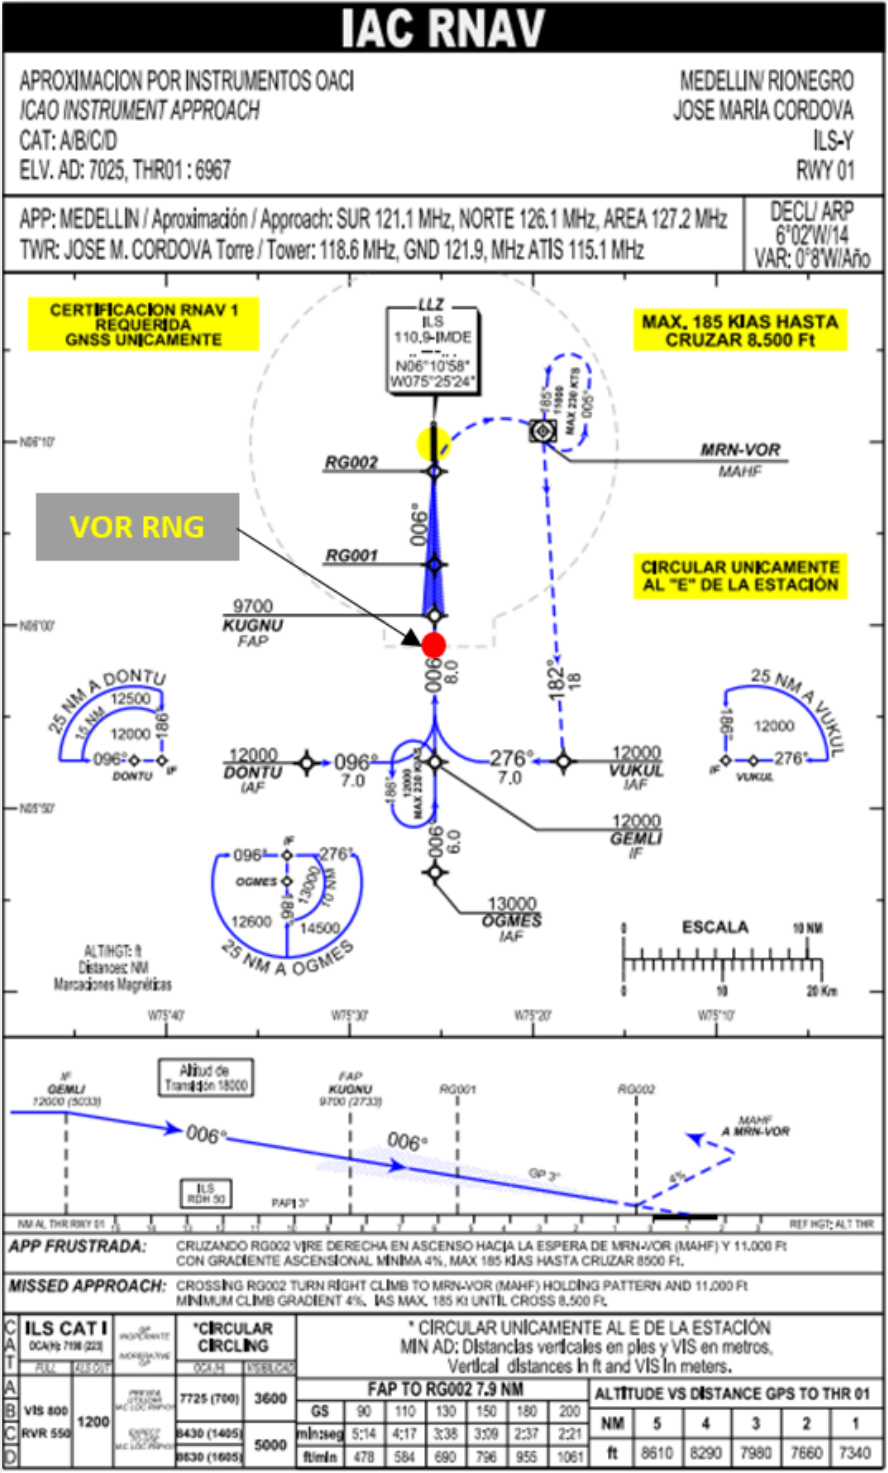
Figure 2. Approach Plate Runway 01, Rionegro

At 02:42:12hrs the crew was instructed to continue descent to FL210. At 02:43:09hrs the crew asked to hold at GEMLI RNAV Point (Figure 2), which was approved. It overflew GEMLI at 02:43:39hrs and entered the hold. (Figure 3 – each complete hold has a ground track of approximately 24 nm).

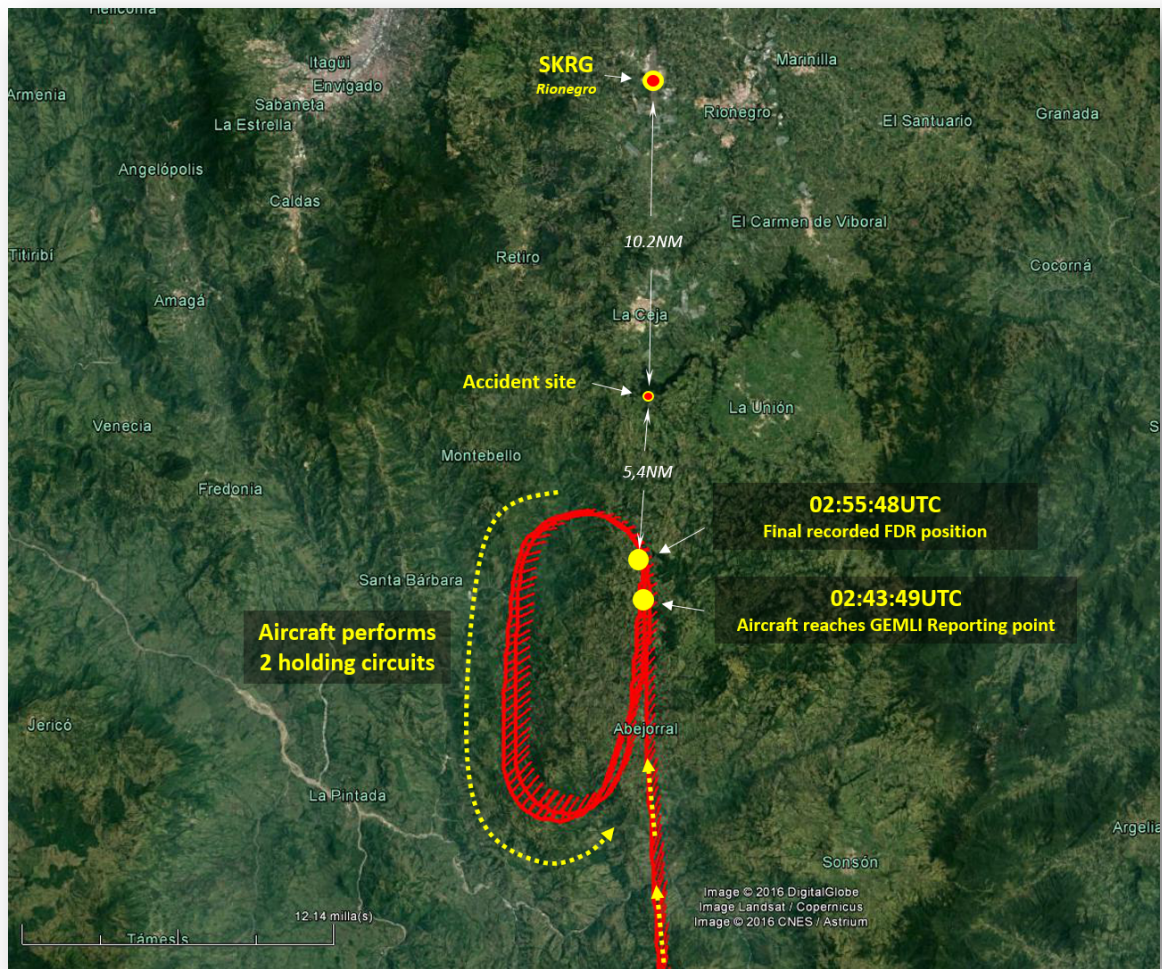
**Figure 3.** Aircraft track in the hold at GEMLI from FDR data

At 02:43:52hrs the aircraft was levelled off at FL210, the flaps lowered to FLAP18 and the speed reduced to 180 kt CAS. At 02:45:03hrs the crew informed ATC that they had entered the hold at GEMLI at FL210.
