**APENDICE "A"****ACCIDENTE HK-4682, SAN ANDRES-COLOMBIA**
**RESUMEN ESTADO FUNCIONAL INFRAESTRUCTURA AERONAUTICA EN  
LA ISLA DE SAN ANDRES- COLOMBIA**

**GROUP CHAIRMAN'S FACTUAL REPORT OF  
INVESTIGATION**

**DCA10RA085**

On August 16, 2010, about 0149 local time (0249 eastern daylight time), an Aires B737-700, HK-4682, crashed short of the runway at San Andres Island Airport (ADZ), San Andres Island, Colombia. There were 121 passengers and 6 crew on board. The airplane was severely damaged and there were 2 fatalities, 15 serious injuries and 66 minor injuries.

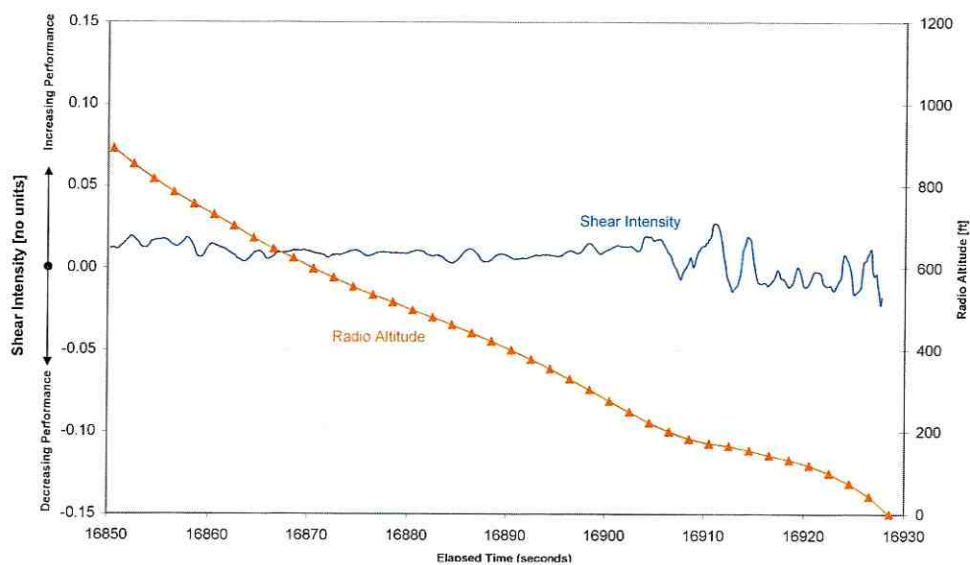
**Aires 737-700 HK-4682**  
**Calculated Shear Intensity**

The WXR does not record actual radar returns, thus the raw data to confirm whether a predictive windshear condition existed is not available. However, based on the observed values of shear intensity which remained below 25% of the "must not alert" threshold, no predictive windshear alert (either caution or warning) was expected.

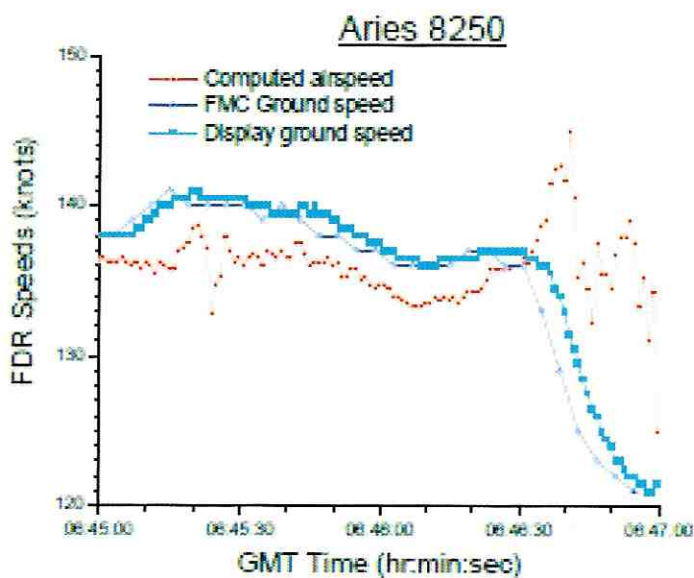
Figure 1 Airspeed and ground speed

Flight data recorder (FDR) data was available for the accident aircraft. Selected FDR data are plotted in figures 1 to 7 for the approach. Pitch, roll and heading are plotted with their associated control inputs in figures 3 to 5. The aircraft was responsive to control inputs.

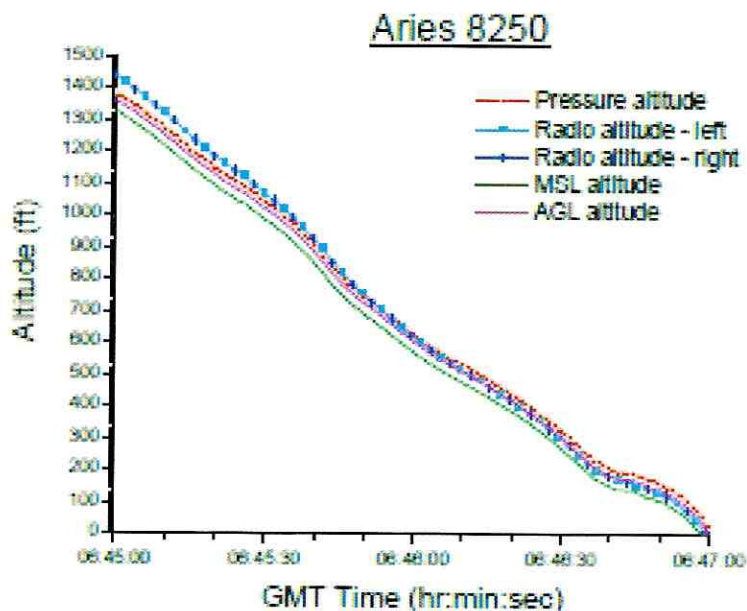
**Figure 8 Altitude**

The mean sea level altitude is plotted with radio and pressure altitudes from the FDR in figure 8. An additional correction of 33 ft was added to this altitude to align the data with ground elevation to produce above ground level (AGL) altitude. The resulting altitude is labeled "AGL altitude" in figure 8.

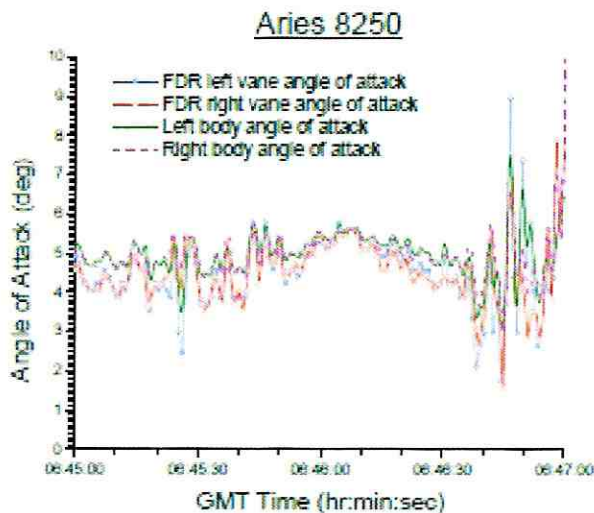
**Figure 10: Angle of attack**

The FDR records vane angle of attack. Vane angle of attack was converted to body angle of attack using the conversion Boeing provided. The resulting body angle of attack is shown in figure 10.

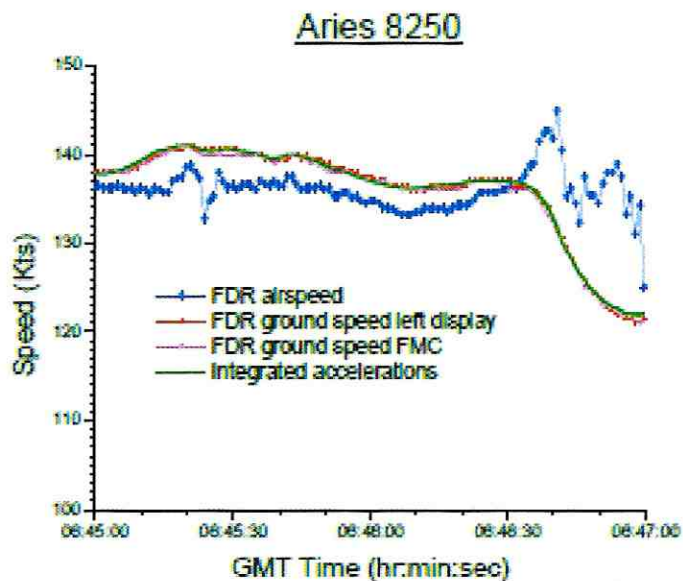
Figure 11 speed comparison

The following offsets were obtained by manual iteration to match the recorded altitude, ground speed and position data. The resulting match with the FDR data is shown in figure 8 through figure 11. The position time history was also derived with a ground speed integration which will be shown for comparison in the position plots that follow.

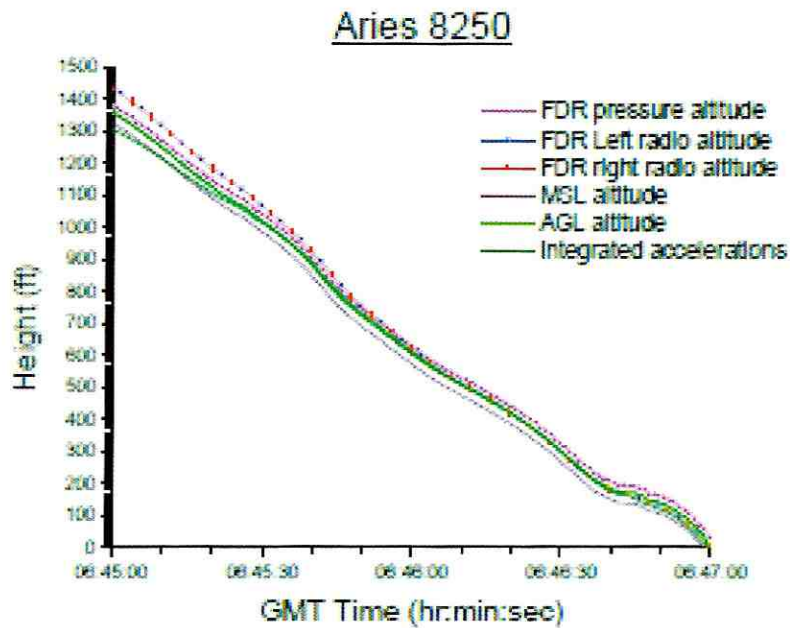
Figure 12 Altitude comparison

Figure 12 shows the match between the altitude from the acceleration integration and the FDR radio and pressure altitude. Figures 13 and 14 show that both the acceleration and velocity integrated flight paths go through the longitude and latitude from the FDR at the proper times.

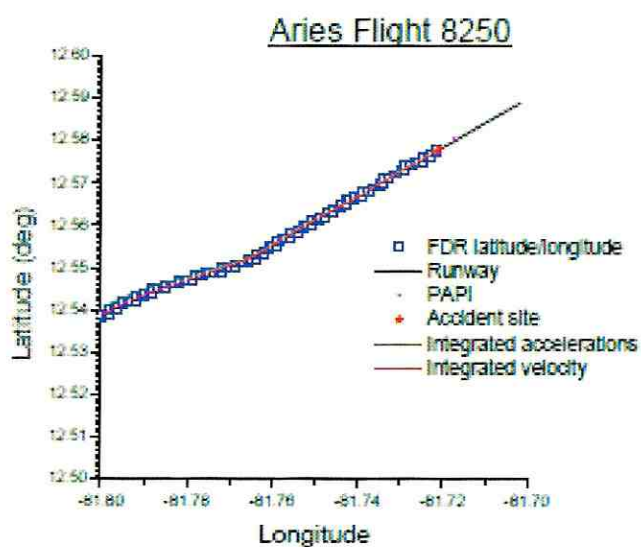
Figure 15 Map view of flight path.

The resulting integrated paths are shown in map view in figure 15. The integrated velocity position, which is the better position time history match to recorded position compared to the acceleration integration, is shown as a Google Earth perspective view in figure 16.

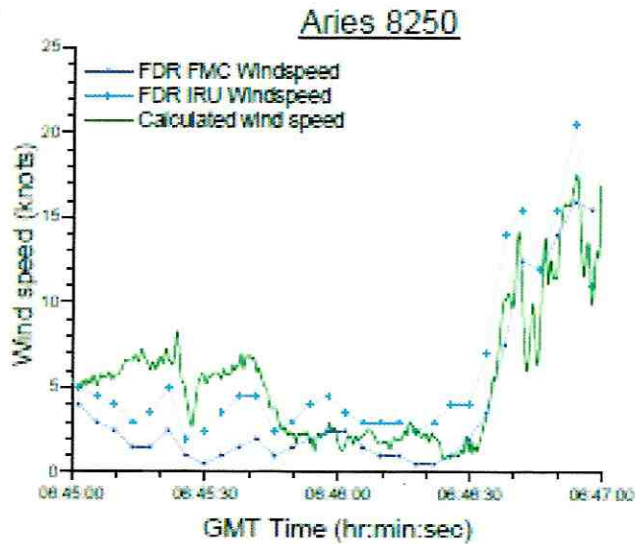
Figure 18 Wind speed

Wind direction and speed was calculated from the time histories of aircraft position determined above and from FDR data (altitude, calibrated airspeed, pitch angle, bank angle & heading). The resulting wind speed is compared to recorded FMC and IRU wind speeds in figure 18. Wind direction is given in figure 19. Wind speed was very light until an approximately 15 kt head wind developed in the last 30 seconds of flight. Note that with light winds, the calculation of wind direction is very sensitive and slight differences in temperature and pressure used in the calculations can make a difference in the result.

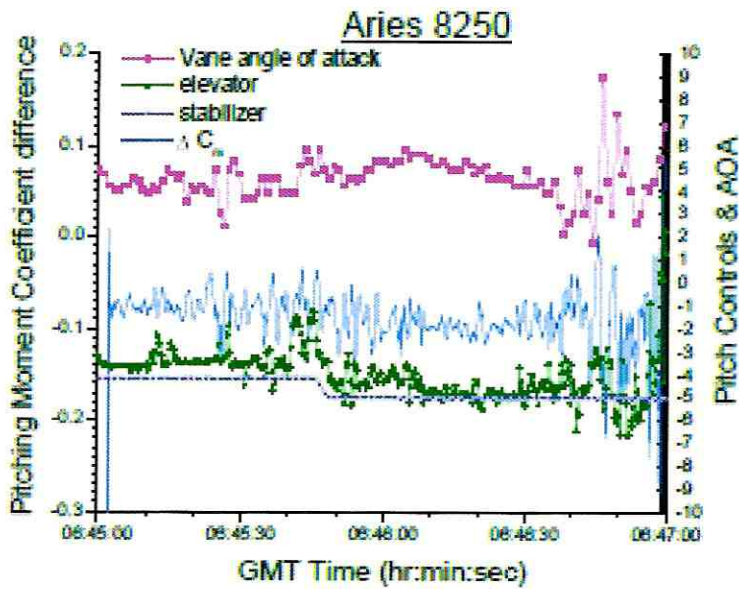
Figure 23 Pitching moment coefficient differences

The effect of rotational winds (or lack thereof) can be seen in the extracted difference in yawing, rolling and pitching moment coefficients. These differences are shown in figures 22 and 23 and represent the difference between the aerodynamic coefficients required for the aircraft's motion and the aerodynamic coefficients from the simulation for the recorded aircraft state and control inputs. Since the difference also includes modeling differences due to the use of the 737-300 model with 737-700 geometry in lieu of a complete 737-700 model, the coefficients differences are plotted with variables that would impact these modeling differences. As can be seen in figure 22 the differences in yawing and rolling coefficients between the model and the accident flight are small and correlate with control movement (where modeling differences are likely). This indicates that any rotational winds in the yaw and roll axis are small. Further, the small fraction of roll and yaw control used indicates that any rotational winds in the yaw and roll axis were easily within controllable limits.

Larger differences due to modeling are to be expected in the pitch axis where pitch trim and controls as well as center of gravity play a role, but, with approximate modeling, incremental changes, not absolute magnitudes are of interest. Differences in pitching moment from the simulator math model are plotted with stabilizer, elevator and angle of attack in figure 23. As can be seen, there are no changes in pitching moment difference that can be separated from

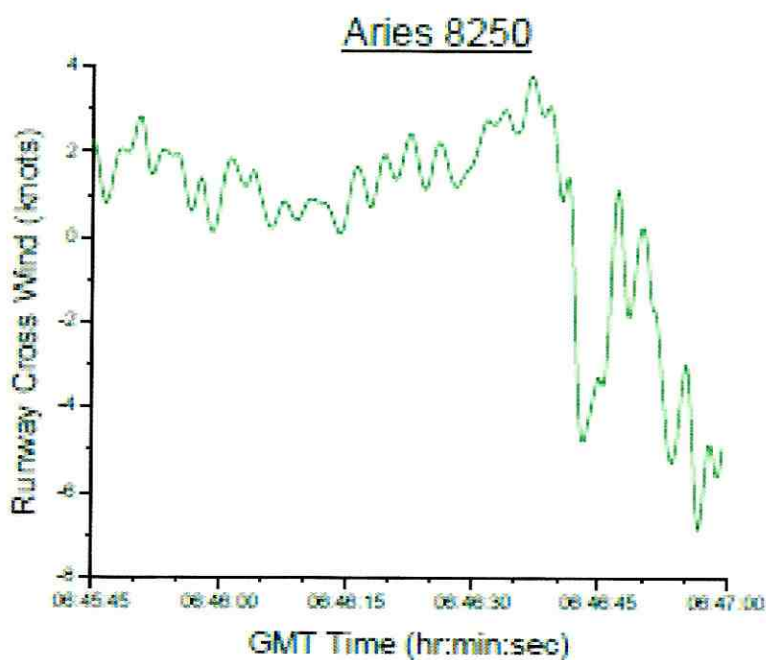
Figure 24: Crosswind component (relative to runway)

Boeing derived the winds from the recorded data. Crosswind relative to the runway is shown in figure 24 while headwind component is shown in figure 25. Vertical wind is shown in figure 26.

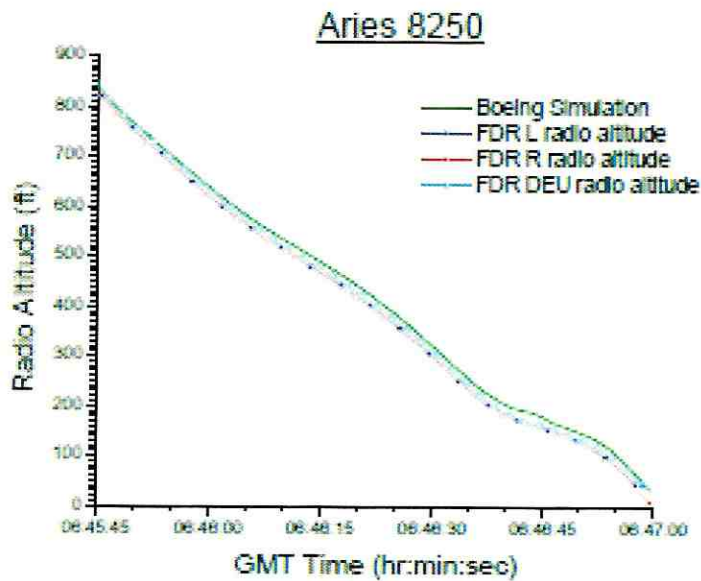
**Figure 27 Altitude match**

Boeing input the winds in figures 24, 25 and 26 into their 737-700 desktop engineering simulation model to study the cause of the motion for the accident flight and to determine whether the airplane behaved as expected for a normal 737-700. Boeing used mathematical pilots to command column and control wheel to match the recorded FDR pitch and roll respectively. The resulting match of radio altitude, groundspeed and airspeed is shown in figures 27, 28 and 29.

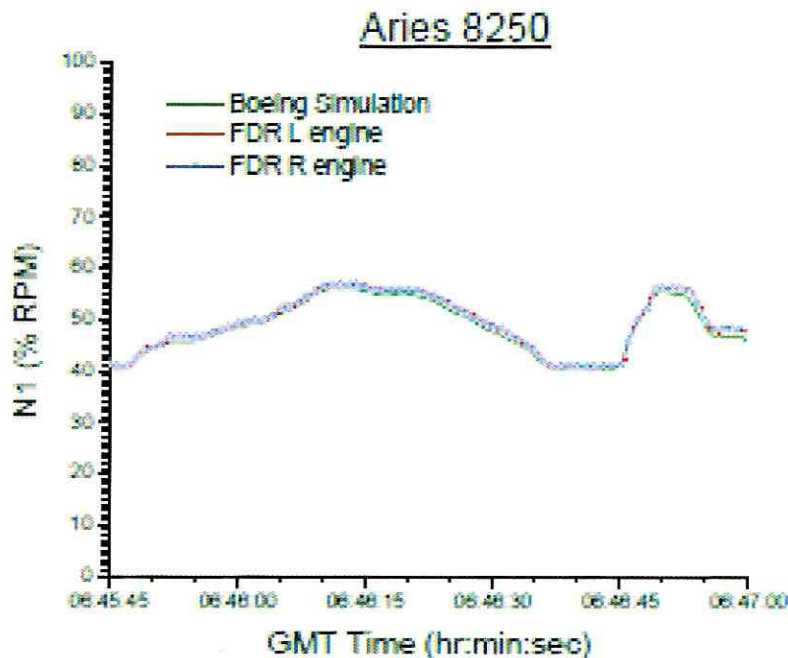
**Figure 31 Engine N1 comparison**

by the FDR would represent unaccounted for forces and moments acting on the aircraft. As can be seen in figures 30 and 31, the control column and power level required to match the airplanes recorded motion (which was essentially in the longitudinal plane for the approach) with the simulation matches the recorded longitudinal controls. Accordingly, the Boeing simulation verifies that the airplane performed as expected in the calculated wind field.
