Grupo de Investigación de
Accidentes e Incidentes aéreos

PRELIMINARY REPORT

Investigation COL-16-37-GIA
Fuel Exhaustion
Accident on 29, November 2015
Aircraft AVRO 146-RJ85, Reg. CP2933
La Unión, Antioquia – Colombia

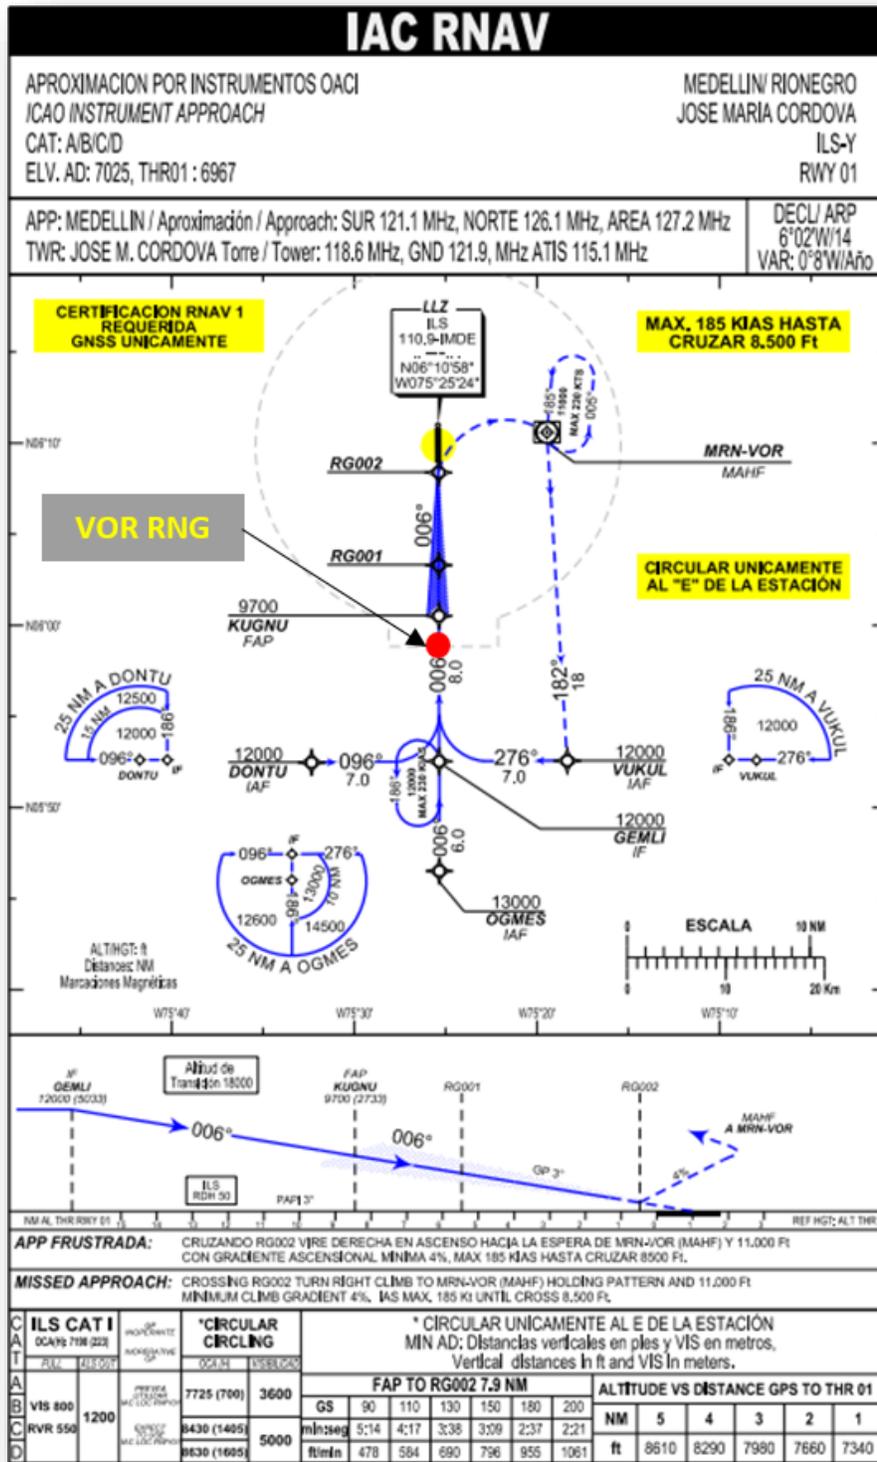
Figure 2. Approach Plate Runway 01, Rionegro

At 02:42:12hrs the crew was instructed to continue descent to FL210. At 02:43:09hrs the crew asked to hold at GEMLI RNAV Point (Figure 2), which was approved. It overflew GEMLI at 02:43:39hrs and entered the hold. (Figure 3 – each complete hold has a ground track of approximately 24 nm).
